BV-AVON 2 MANDAY FACTORY AUDIT CHECKLIST WITH ROHS - 29JAN2014 (AVON INTERNATIONAL)

BV Ref:	10202261397		
Auditor:	JEVONS HE		
Audit Date:	SEP 07, 2020 - SEP 07, 2020		
Date of Previous Audit:	Jul 05, 2019		
Previous Audit #:	10191631847		
Vendor Name:	THE HOUSE OF BUSBY		
Factory Name:	JIAXING JIAXIDA LEATHERWARE CO LTD		
Address:	NO.193 YUANFENG ROAD XIUZHOU DISTRICT JIAXING		
E-Mail Address:	Lydia@layogroup.com		
Tel:	8657382076819	Fax: 86-573-89977444	
Country:	CHINA

Against BV-Avon Factory Assessment Protocol – 2 MD

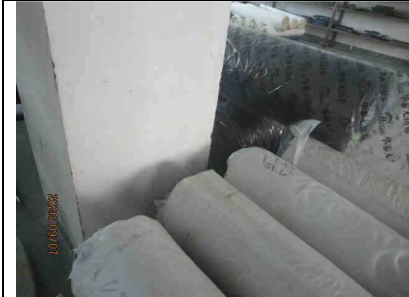
2.11.2	All finished goods and materials shall be stored at least 45 cm from walls or elevated off the floor.	Minor (YELLOW)	Per onsite observation, it was noted the finished goods were properly stored at least 45 cm from walls and elevated off the floor, but parts of the fabrics (around 5 rolls) were stored close to interior wall stud at fabrics storage area.
3	PRODUCT CONTROL

7) Parts of fabrics were stored close to interior wall stud

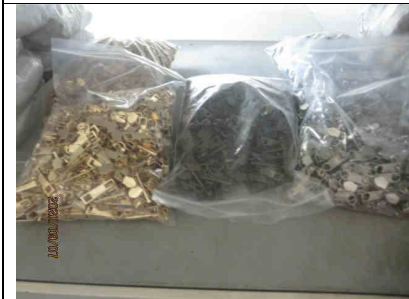
1.9.2	Raw materials (including packaging), work in progress and finished products shall be identified to ensure traceability.	Minor (YELLOW)	Per onsite observation, it was noted the finished products, semi-finished products and most of the incoming materials (such as fabrics and package) were properly identified with labels to ensure the traceability, except some zipper pullers (at least 3 bags) stored at trims warehouse were not identified with label to ensure the traceability.

10) Some zipper pullers (at least 3 bags) were not identified with label at trims warehouse

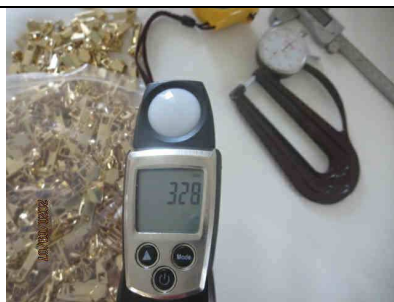
2.3.1	Premises are sufficiently illuminated in order to permit effective cleaning, production, monitoring, and inspection.	Minor (YELLOW)	Per on site check by lux meter, it was noted the lighting was insufficient at incoming materials inspection area (328 lux), in-line inspection area of gluing workshop (210 Lux) and final products inspection area (507 Lux).

14) Insufficient lighting at incoming materials inspection area (328 Lux)

For reference, the lighting should be no less than 1000 lux at inspection areas.
2.3.3	Where appropriate, humidity and ambient temperatures are controlled to ensure product integrity.	Minor (YELLOW)	The factory established the documented procedure (File No.: JXD/QP26-2016) for humidity and ambient temperatures control, and installed the thermo-hygrometers at some working areas, such as sewing workshop for humidity and ambient temperatures control, but did not install the thermo-hygrometer at trims warehouse and finished goods warehouse for humidity and ambient temperatures control.

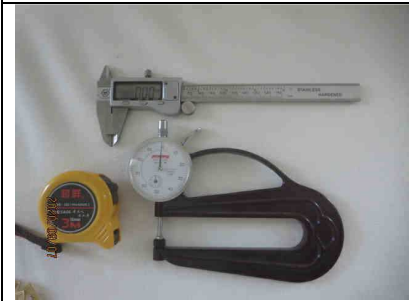
4.7.2	Measuring and monitoring equipment is routinely calibrated to recognised national standards.	Minor (YELLOW)	The factory established the calibration procedures for measuring equipment, and maintained the calibration plan and valid calibration certificates for all measure equipment, such as light box, thickness tester etc. However, per onsite observation, it was noted the calibrated tape measure, caliper, thickness tester and light box used at incoming materials inspection area were not affixed with the calibration stickers or labels.

16) Tape measure, caliper and thickness tester were not affixed with calibration stickers at incoming materials inspection area

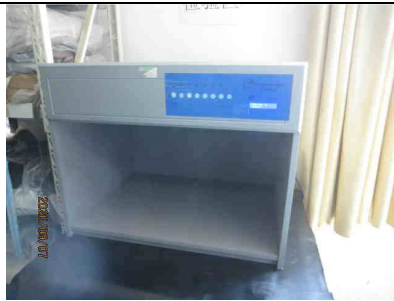
17) light box was not affixed with calibration sticker at incoming materials inspection area

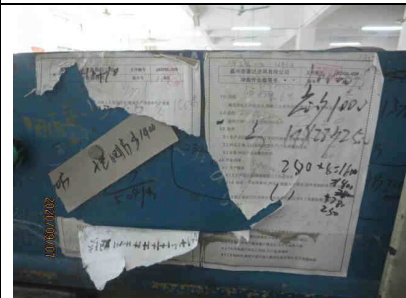
1.15.5	All documents in use are the correct version.	Minor (YELLOW)	Most of the quality documents, such as the quality procedure, inspection instructions and etc. in use were correct version, except the operation guidance posted at sewing workshop was not controlled by version. Furthermore, one controlled work instruction posted on die-cutting machine was stained and broken.
2	GOOD MANUFACTURING PRACTICE (GMP)

21) The controlled work instruction posted on die-cutting machine was stained and broken

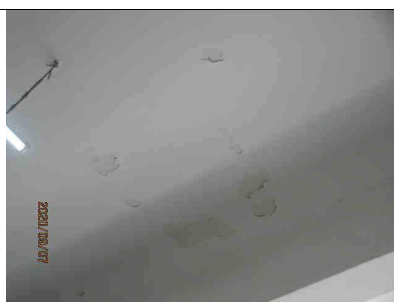
2.1.1	Building exterior and interior shall be maintained in good conditions to prevent product contamination.	Minor (YELLOW)	The building exterior and most of the building interior was acceptable, except parts of ceiling was peeling off cements at fabric cutting workshop.

23) Parts of ceiling was peeling off cements at fabric cutting workshop.

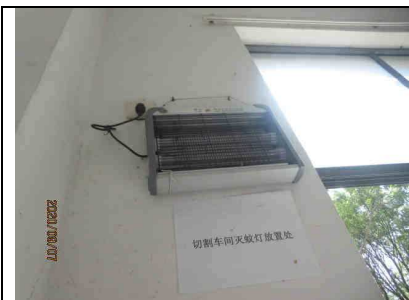
2.7.1	The company shall either contract the services of a competent pest control organisation, or shall have trained personnel, for the regular inspection and treatment of premises to deter and eradicate infestation. Where the services of a pest control contractor are employed, the service contract shall be clearly defined and reflect the activities of the site.	Minor (YELLOW)	The factory established the pest control procedure (File No.: JXD/QP25-2016) and conducted the pest control by internal trained personnel, also maintained related pest control records. However, per onsite observation, it was noted one set of fly kill lamp installed at cutting workshop was not working properly; furthermore, one set of mouse trap installed at cutting workshop was not supplied with bait.

25) One set of fly kill lamp installed at cutting workshop was not working properly

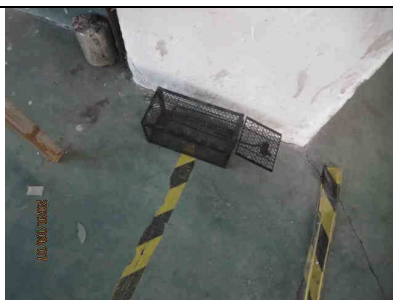
26) One set of mouse trap installed at cutting workshop was not supplied with bait

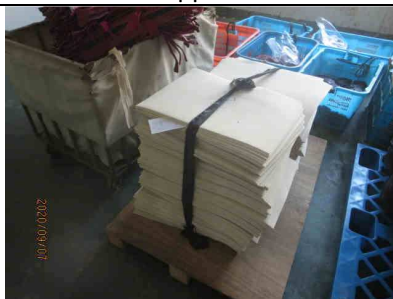
3.5.1	Procedures shall be in place to prevent the contamination of raw materials, packaging and finished products.	Minor (YELLOW)	The factory established the procedure to prevent the contamination of raw materials, packaging and finished products, and most of the materials and products were properly protected, except one palletized of cut panels with light color were bundled by dark strings at cut panels storage area.

29) One palletized of cut panels with light color were bundled by dark strings at cut panels' storage area

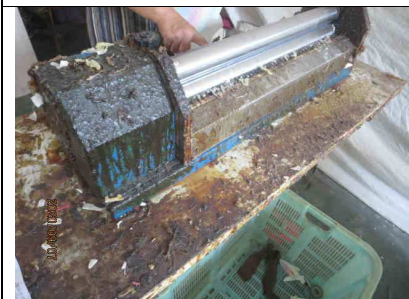
31) The surface of one sampled gluing machine was very dirty

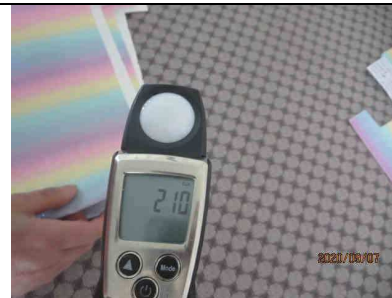
36) Insufficient lighting at in-line inspection area of gluing workshop (210 Lux)

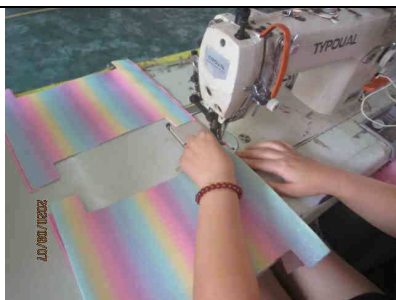
2.6.3	No evidence of employee wearing jewellery, watches, other potentially contaminating apparel (check company's policy) observed.	Minor (YELLOW)	The factory established the policy for jewelry control, but it was not implemented strictly, such as one employee was wearing bracelet while working at sewing workshop.

41) One employee was wearing bracelet while working at sewing workshop

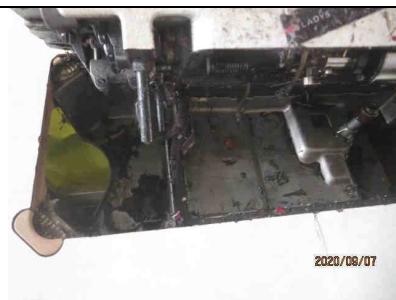
2.4.2	The company shall establish maintenance program to ensure all equipment and production machinery are adequately maintained.	Minor (YELLOW)	The factory established the maintenance program included the daily/monthly/yearly maintenance plan for machines and tools, and maintained the related maintenance records. However, per on site observation, it was noted the surface of 1 out of 2 sampled gluing machines was very dirty; furthermore, 1 out of 3 sampled sewing machines had dirty oil tank and low oil level at sewing workshop.

42) One set of sewing machine had dirty oil tank and low oil level

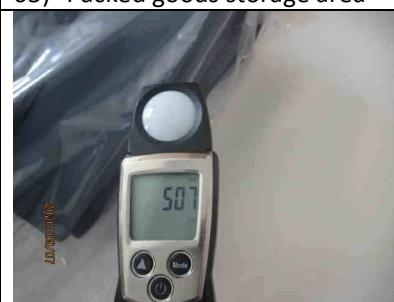
66) Insufficient lighting at final QC area (507 Lux)
