BV-AVON 2 MANDAY FACTORY AUDIT CHECKLIST WITH (AVON INTERNATIONAL)

BV Ref:	10180661528		
Auditor:	MONICA MIAO		
Audit Date:	Mar 30, 2018		
Date of Previous Audit:	Apr 07, 2017		
Previous Audit #:	10170390375		
Vendor Name:	THE HOUSE OF BUSBY		
Factory Name:	JIAXING JIAXIDA LEATHER CO LTD		
Address:	NO.193 YUANFENG ROAD XIUZHOU DISTRICT JIAXING		
E-Mail Address:	XLF@LAYOGROUP.COM		
Tel:	86-573-82076819	Fax: 86-573-89977444	
Country:	CHINA

BV-Avon Factory Assessment Protocol – 2 MD

Women's Handbags

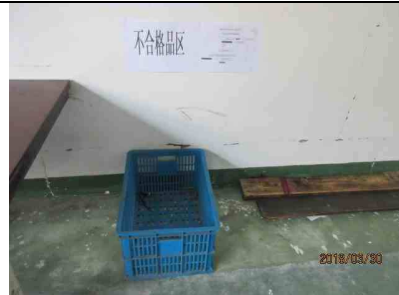
16) Insufficient lighting at incoming inspection area (510 lux)

2.3.1	Premises are sufficiently illuminated in order to permit effective cleaning, production, monitoring, and inspection.	Minor (YELLOW)	By lux meter checking during factory tour, lighting conditions for incoming inspection area (510lux) and finished products inspection area (848 lux) were insufficient (Below 1000 lux).

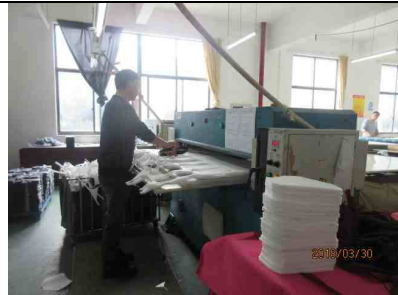
21) Some trashes were found on floor of die-cutting area.

2.5.1	Cleaning practices shall be completed so as to minimise risk of contamination.	Minor (YELLOW)	The factory conducted 5S management system in the factory, cleaning schedule & records were provided for review, but some trashes were found on floor of die-cutting area.

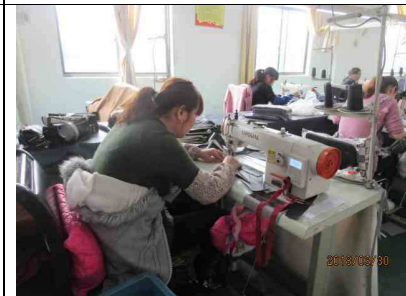
46) Some sewing machine was not clean

2.4.2	The company shall establish maintenance program to ensure all equipment and production machinery are adequately maintained.	Minor (YELLOW)	Machine maintenance program was established and performed in the factory, and relevant maintenance records were maintained for review. But per factory tour, some sewing machine was not clean.

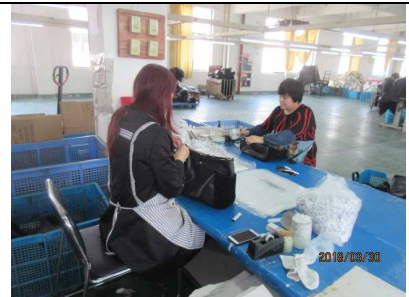
62) Some employee was wearing earring while working

2.6.3	No evidence of employee wearing jewellery, watches, other potentially contaminating apparel (check company's policy) observed.	Minor (YELLOW)	Company's control policy for employee jewelry, watch and other apparel control was established, but it observed that some employees were still wearing jewelry and watches, etc. at finishing and packaging area.

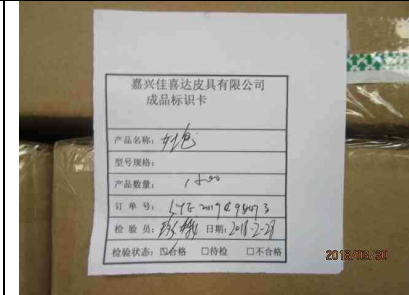
67) Some finished products were turned over

3.5.1	Procedures shall be in place to prevent the contamination of raw materials, packaging and finished products.	Minor (YELLOW)	Written procedure was established to protect the materials, semi-products and final goods during carrying and storage, etc. Per factory tour observation, most of materials, semi-products and final goods were well stored, but some cutting panels in light color were stored with protective cover, and some finished products were turned over.
4	PROCESS CONTROL
